Increasing the Electric Strength of a Vacuum-Insulated Tandem Accelerator

Abstract—The electric strength of ceramic insulators was tested at a dedicated high-voltage vacuum facility and the electric strength of a vacuum-insulated tandem accelerator with redesigned feedthrough insulators was studied. Based on the results of the investigations and the upgrade the voltage in the accelerator was increased from 1.00 to 1.15 MV; the operating mode was achieved without high-voltage breakdowns.

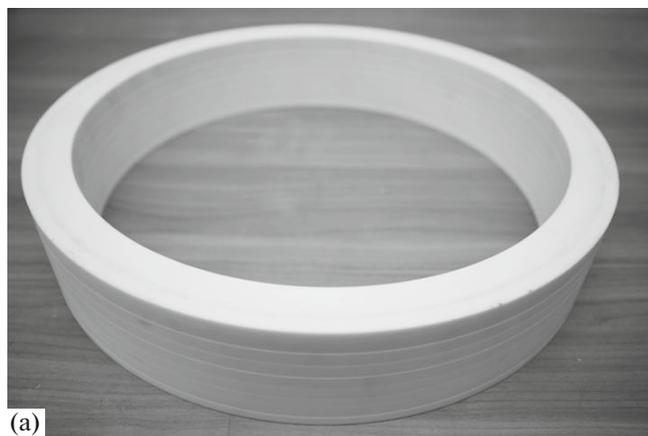
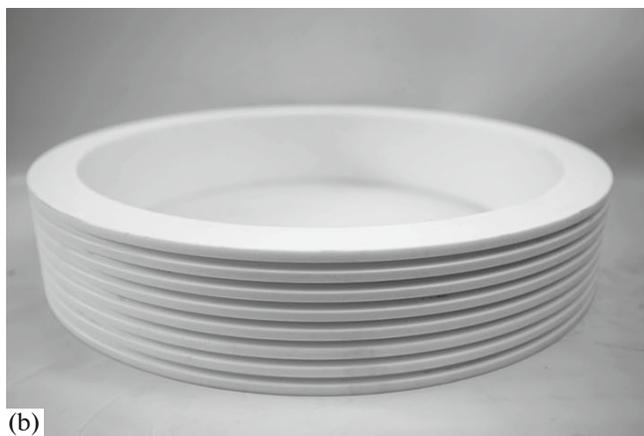
Fig. 5. The ceramic insulators with (a) smooth and (b) ribbed outer surfaces.

The examined ceramic rings had a height of 73 mm, an external diameter of 394 mm, an inner 336 mm, and smooth (Fig. 5a) and ribbed (Fig. 5b) vacuum surfaces. The residual gas pressure during the experiment was 2×10^{-4} Pa.
